Long-Term Lift Station Rehabilitation at Jefferson Parish, Louisiana

By: Gary R. Hall, David E. Snider and Gregory J. Emish of Sauereisen, Inc.

CASE HISTORY: LIFT STATION REHAB IN LOUISIANA

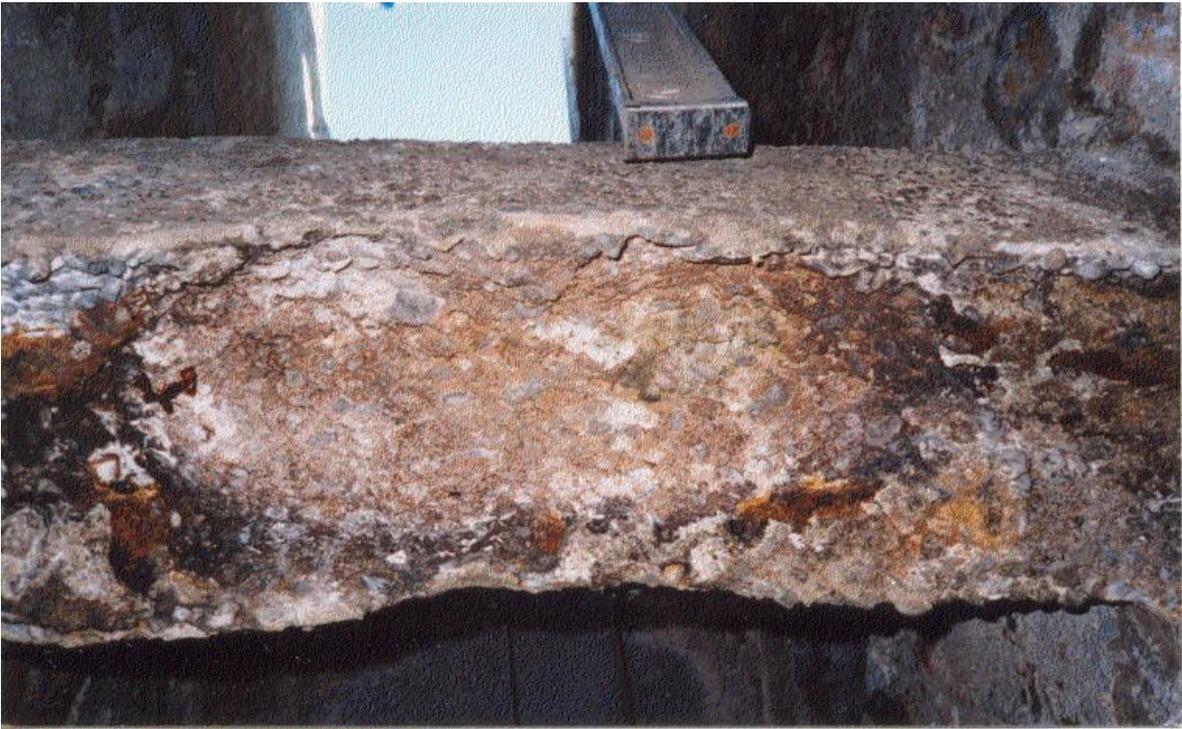
The concrete lift station, placed into service in 1972, measured 8 ft. x 3 ft. x 23 ft. Inside, two Force Mains (measuring 8" dia. and 10" dia.) and two Gravity Mains discharged into the Lift Station. After approximately fifteen years of such high duty service consisting of turbulent flow, abrasion and chemical attack due to MIC, it wasn't surprising that extensive corrosion occurred. Worn aggregate, exposed

reinforcing steel and severely spalled concrete were present throughout the structure. (see Figures 2, 3, 4).

Figure 2. Lift Station Prior to Rehabilitation.

Sauereisen's pre-qualified applicator for the project was Slidell, LA contractor Python Construction. Extensive preparation was performed on the concrete surface of the Lift Station. This preparation utilized typical techniques that included hydroblast equipment and air hammers to remove loose, weak, chemically attacked concrete and contaminants while the sewage was diverted, during the installation of new pumping equipment.

Once the surface preparation was complete, a fast-setting, cement-based underlayment was applied to restore structural integrity of the concrete and to provide a uniform surface for application of the corrosion-resistant lining. The selection of the proper underlayment is critical, as many substrate repair materials will tend to soften and re-emulsify in immersion conditions. The underlayment must also be compatible with the corrosion-resistant lining in order to provide a strong firmly bonded monolithic structure.

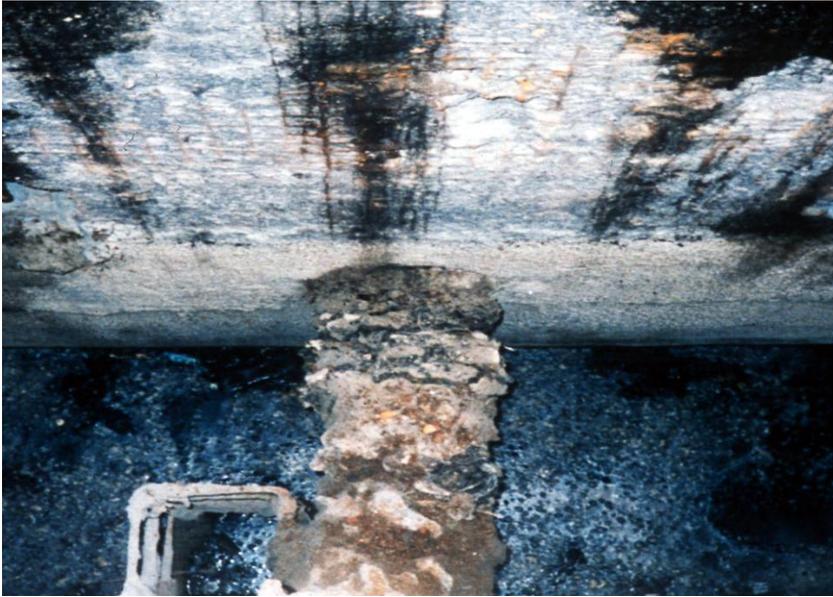
Figure 3. Lift Station Prior to Rehabilitation.

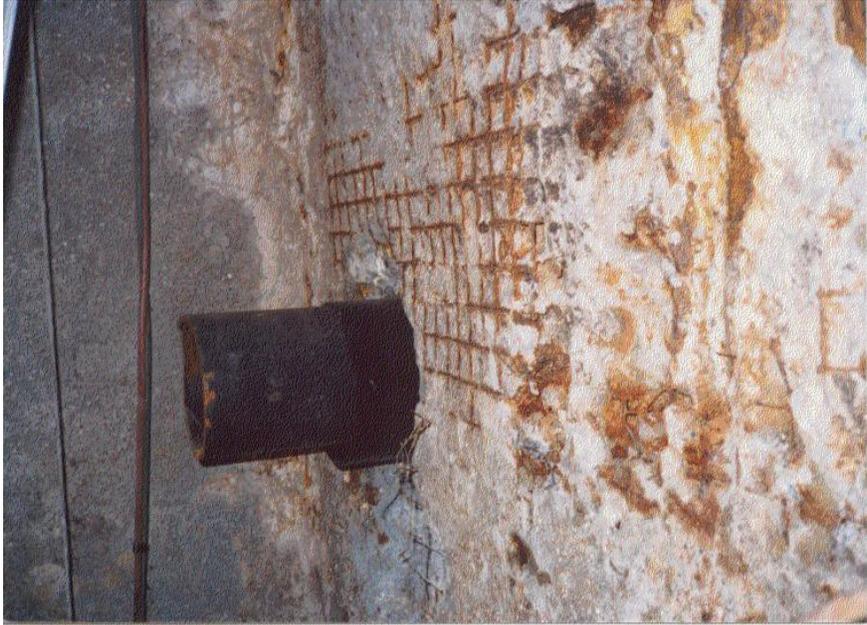
Figure 4. Lift Station Prior to Rehabilitation.

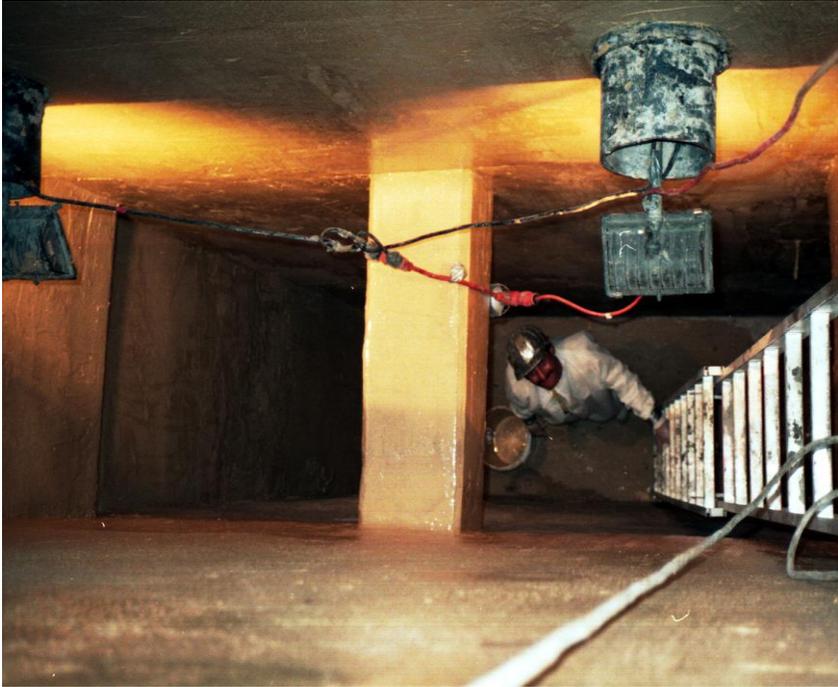
The corrosion-resistant lining was then applied to a 1/8-inch thickness with a single pass of a trowel. The surface was rolled with an 8-inch short-nap roller, which provided a uniform monolithic

surface, free of pinholes, laminations and irregularities. The total application time, including surface preparation, was three days, and the lift station was returned to service within 24-hours after installation of the corrosion-resistant lining. (See Figure 5)

Figure 5. Rehabilitated Lift Station.

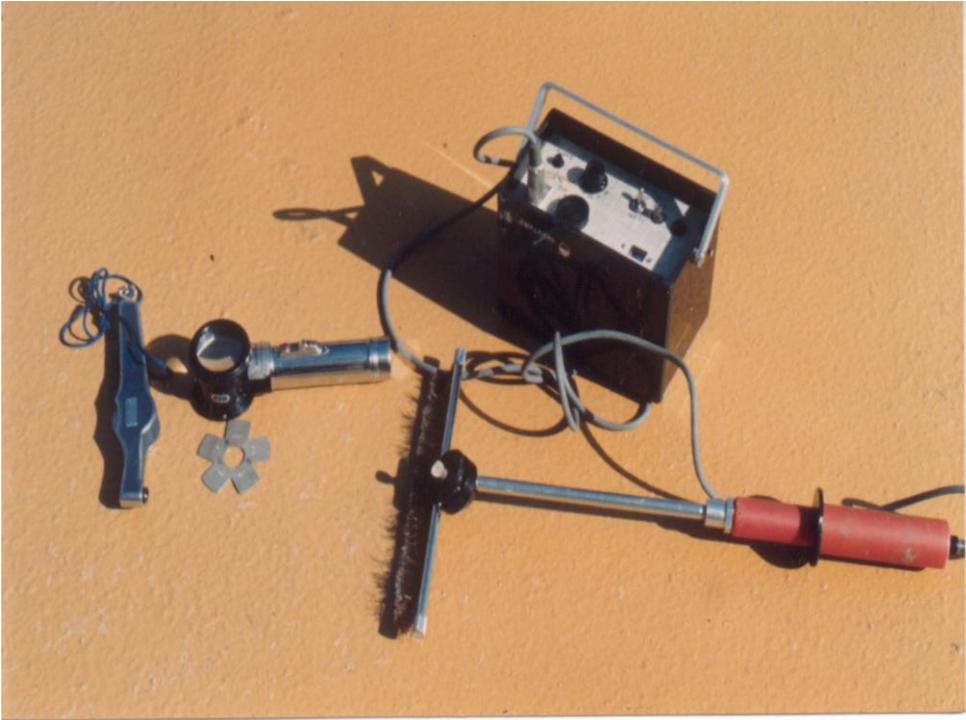
As a Quality Assurance measure, the lining was then spark tested (see Figure 6). High Voltage Spark Testing reveals any type of defect in the lining, many of which are not visible to the naked eye. Left unrepaired, these defects would allow water, sewage, bacteria and other corrosives to undercut the lining, leading to premature failure. The installation contractor easily repaired the identified areas and then retested the repaired areas. This testing process ensured a pinhole-free lining, which translated to optimum performance of the lining.

Figure 6. Typical Spark Testing Unit.

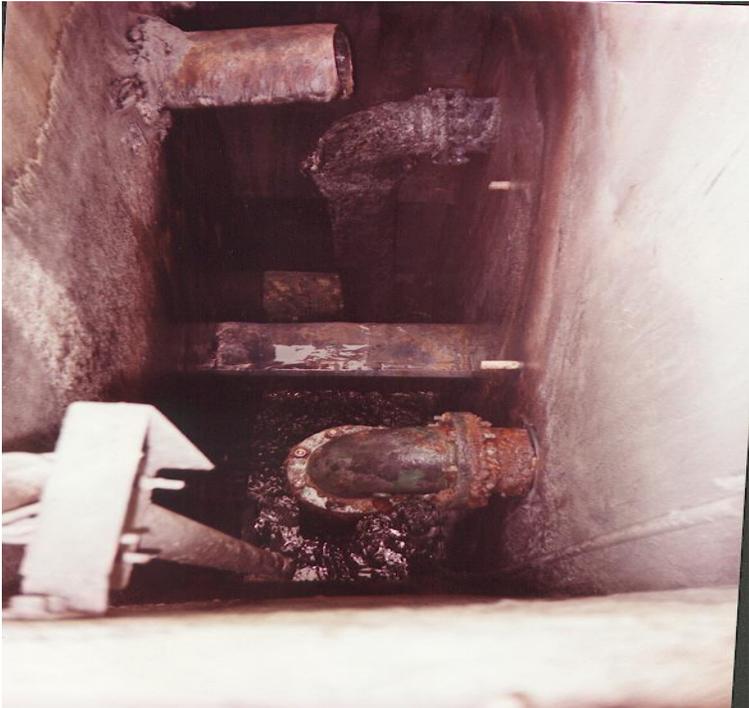
After almost fifteen years of prolonged service life, the municipality and Sauereisen technical personnel jointly inspected the lining in March 2002. In the ensuing years since 1988, the demanding service of this Lift Station had actually increased because of considerable development within the Parish. Consequently, expectations were that the structure could be in need of at least some degree of maintenance once again.

The epoxy lining, however, has been able to withstand these higher service levels. In an environment where cement loss due to corrosion typically measures 1/8 to 3/4 inch per year, the epoxy product has shown no signs of chemical attack or erosion. It is in excellent condition and firmly bonded to the substrate. No blisters, spalling or cracks have been observed and no chemical attack is present. (see Figure 7).

Figure 7. Lift Station in 2002.
