Practical Approach to Selection, Application & Inspection of Organic and Inorganic Wastewater Linings

~ 2009 UCT Corrosion Conference ~

By: Lake H. Barrett and David E. Snider, Sauereisen, Inc.

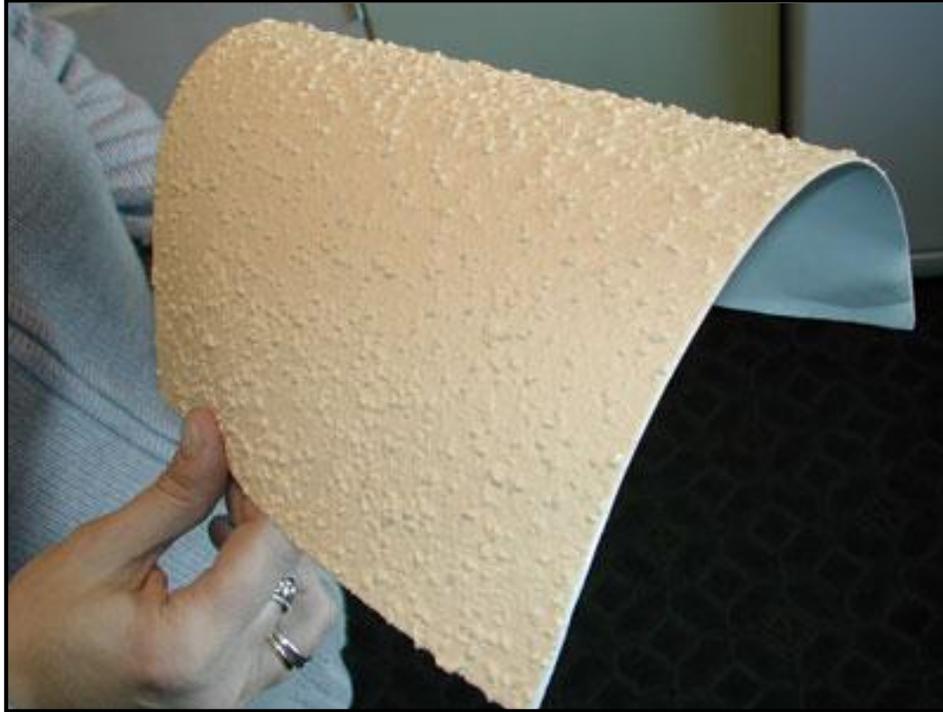
When compared to their Epoxy counterparts, Polyurethane and Polyurea technologies are newer to the wastewater industry. They offer excellent flexibility, quick cure capabilities, moderate chemical resistance and a single coat application. Polyurethane (reaction of a urethane and isocyanate) derivatives are moisture sensitive, so their application in damp environments can create adhesion concerns, so the use of primers becomes paramount. The polyurea systems (reaction of a urethane and amine) provide moisture tolerance but have reduced chemical resistance.

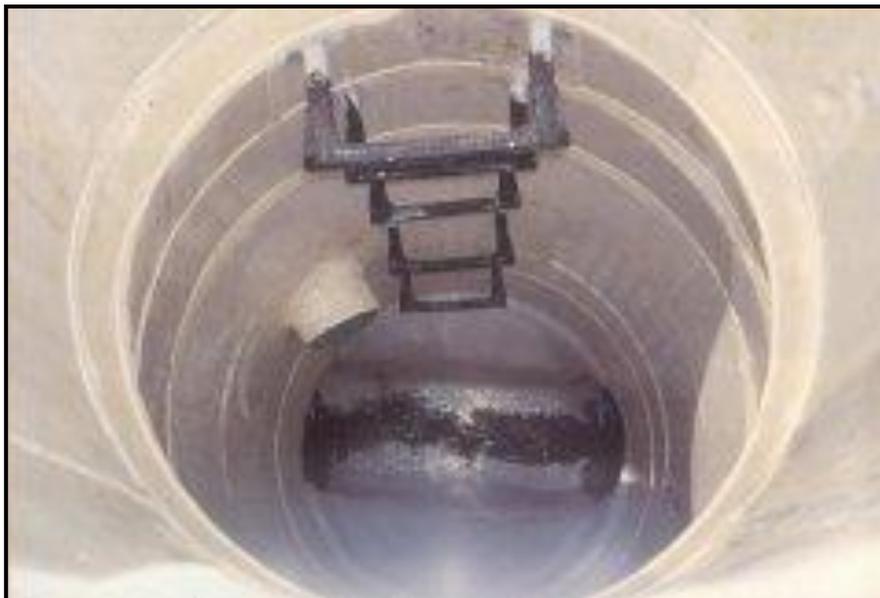
Plastic Sheet Goods consisting of Poly-Vinyl Chloride (PVC) and High Density Polyethylene (HDPE) have been used in water and wastewater pipe with very good success. These materials offer excellent chemical resistance and low permeation and are ideal for applications that can be completed in a shop environment such as reinforced concrete pipe manufacturer. It is more difficult to apply these materials in-situ as they need to be formed in place and the seams between the sheets must be welded or taped.

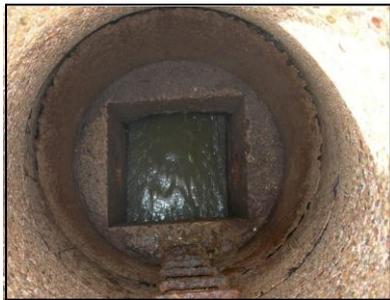
Figure 1.

1. Surface Preparation consisted of high-pressure (5,000 psi) water blasting to remove all weak, acid-attacked concrete. (Figure 1 – shows the condition of the prepared substrate)

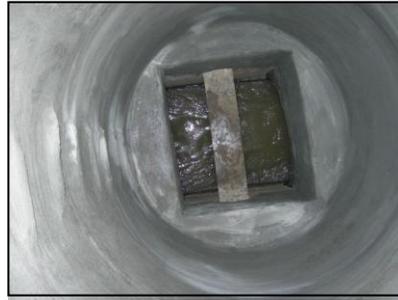
Figure 2.

4. A fast-setting waterplug was used to stop a small amount of infiltration, which existed.
5. A fast-setting, cement-based resurfacer was applied to a thickness of ¼” to the interior of all prepared manholes. This step provides a uniform surface for application of the protective lining material. A consistent thickness of the protective liner can then be tested for pinholes. (Figure 2 illustrates the resurfaced structure)

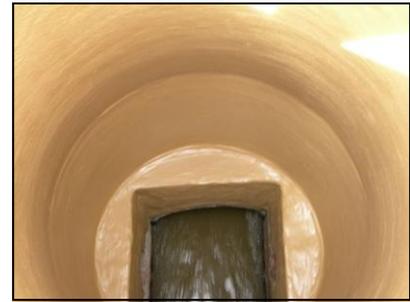
Figure 3.

7. After a 24-hour cure the epoxy lining was tested for adhesion, using the same method employed for determining tensile strength of the substrate.
8. The epoxy lining was then tested for pinholes or “holidays.” The detected pinholes were easily repaired, providing a monolithic, pinhole-free lining. (Figure 3 illustrates a completed structure)

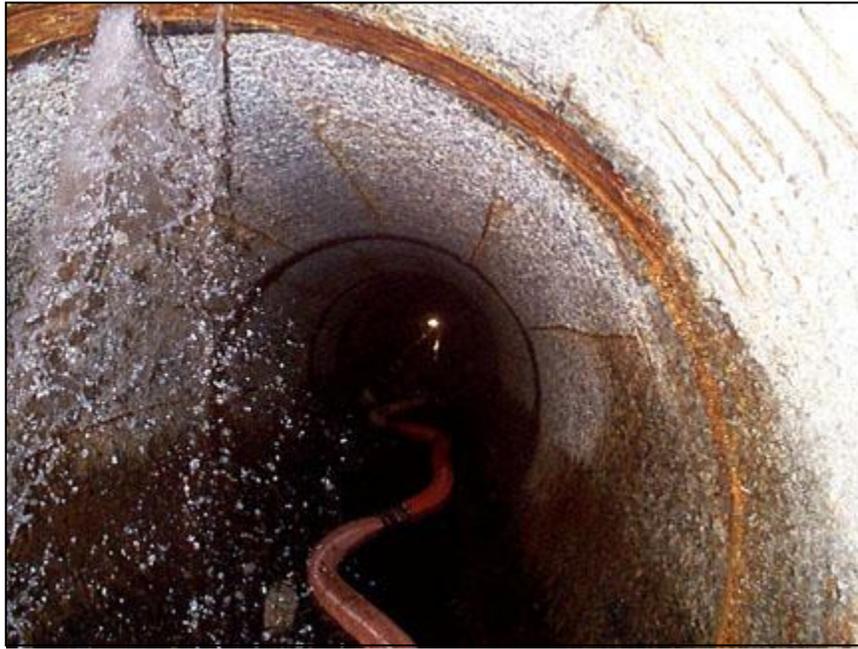
1 - Pipeline showing dramatic evidence of corrosion and water inflow.

As the project commenced, it was quickly learned that degradation of the line was much more extensive than originally thought. Ultra-high pressure water blasting was removing up to 4 inches of weak, chemically attacked concrete. In addition, much of the steel reinforcement was damaged beyond repair. The following steps were required for completion of this project:

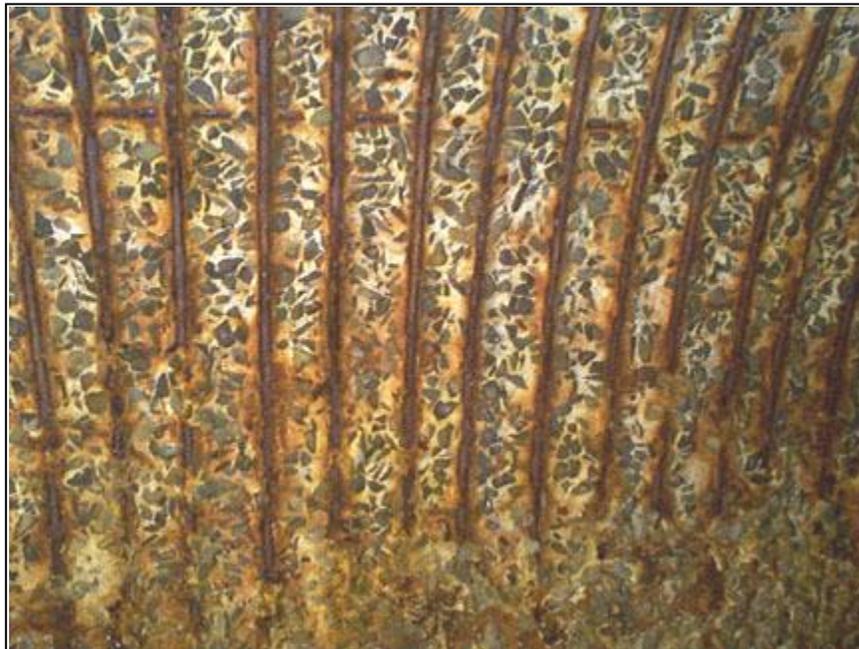
#2 – Exposed aggregate and corroded rebar illustrate the critical need for restoration.

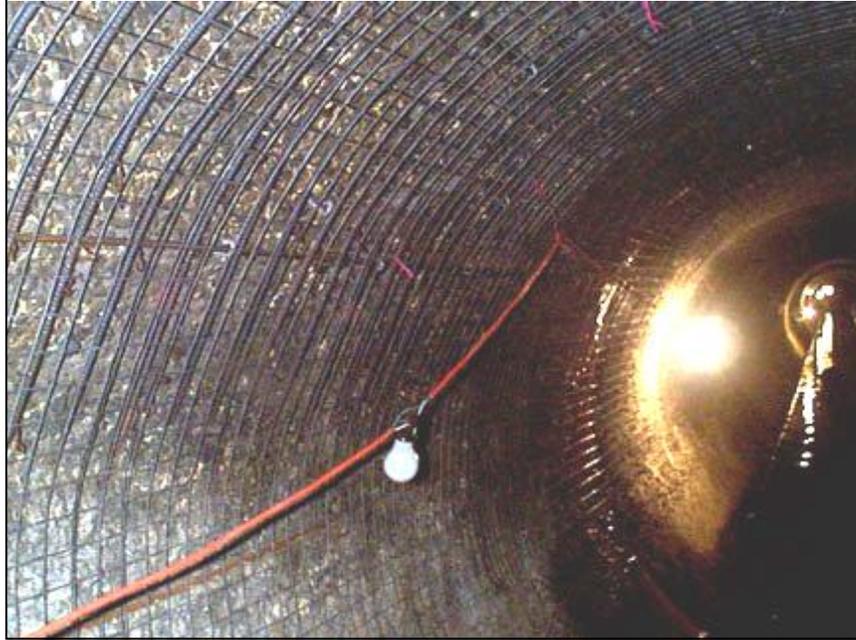
#3 – Newly installed rebar awaits gunite-applied concrete restoration.

1. After surface preparation, an extensive amount of pressure grouting with hydrophilic polyurethane was performed to eliminate inflow and infiltration.
2. New reinforcement was installed for the application of a repair material.

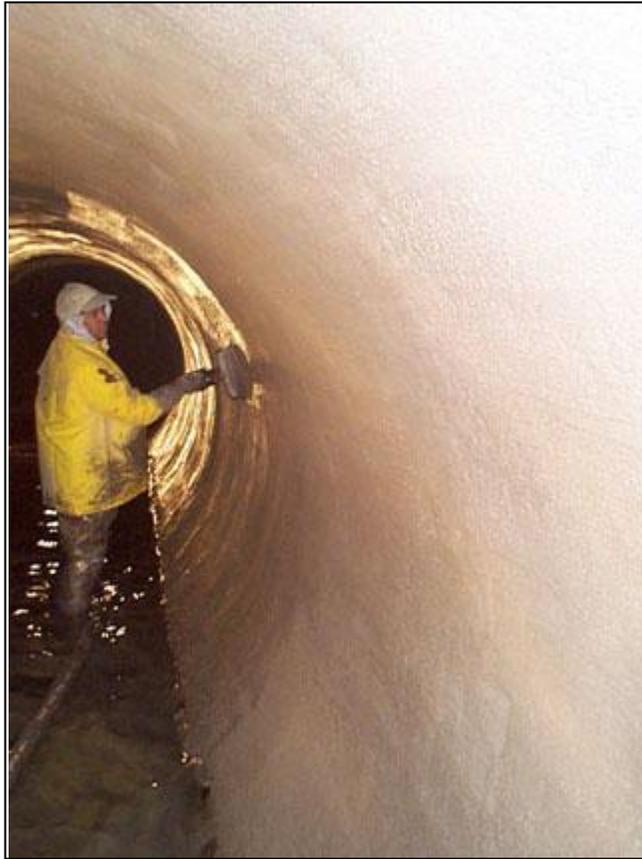
#4 – Finishing touches applied to the underlayment prior to application of protective epoxy lining.

As each area of the gunite application of the substrate resurfacer was completed it was given a broom finish. This provided a mechanical profile to bond the polymer lining, which was spray applied by the contractor after all the underlayment work was completed.

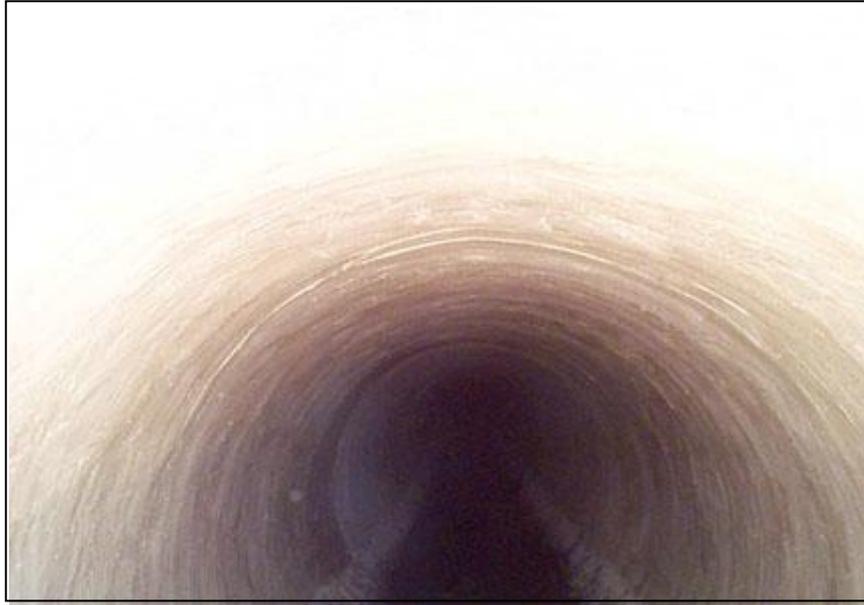
5 - Completed pipeline with concrete restoration and corrosion resistant hybrid polymer lining.

This 100% solids hybrid polymer lining system will prevent any further corrosion in this aggressive environment.
