## Lining Project Restores Wastewater Treatment Clarifiers

When tasked with restoring 14 concrete clarifiers, important structures in the wastewater treatment process, the Clark County Water Reclamation District (CCWRD) faced several challenges such as airborne dust, hot and arid conditions, the implementation of a system mockup and an emphasis on in-field quality control.

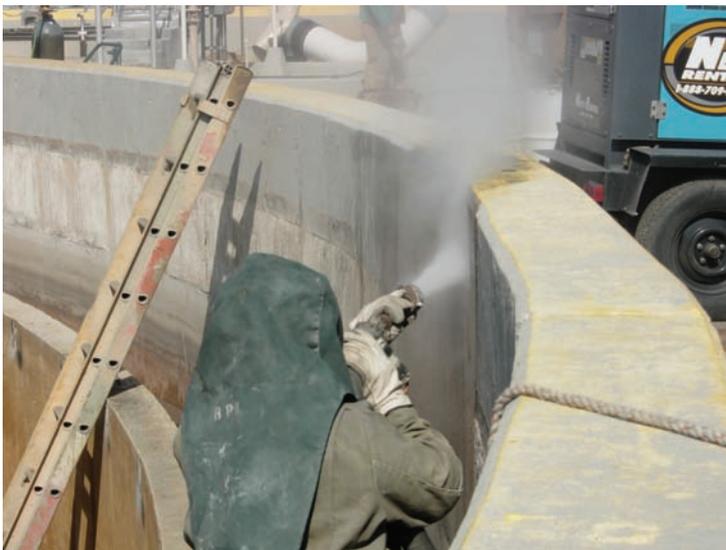
A combination of abrasive and high-pressure water was used to prepare the concrete.

The contractor on this project quickly realized that the amount of dust generated from the abrasive blasting was not compatible with coating. To overcome this challenge the project team employed a combination of abrasive and water, which dramatically reduced dusting and provided the required surface profile.

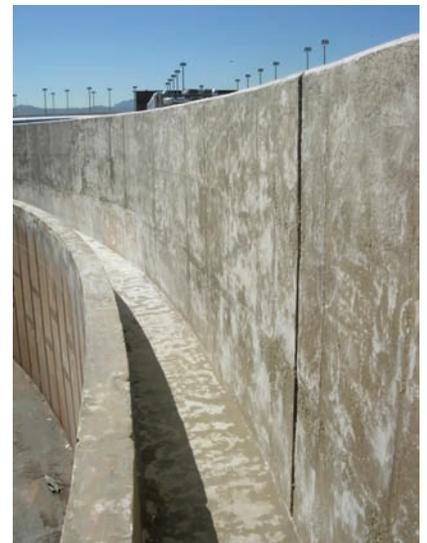
Condition of structure following re-surfacing with a light-weight epoxy underlayment.

The project included an open-top structure with high temperatures and swirling winds, making the use of cement-based resurfacing material problematic. Under these conditions cementitious repair material is prone to cracking and delaminating. The project team determined that the solution was to use an epoxy-based repair material, one which didn't require a pre-dampened substrate or post-curing with water. The result was a strong, firmly-adhered repair material, which restored the structure to its "pre-corrosion" dimension. The application of the protective lining material could then proceed.

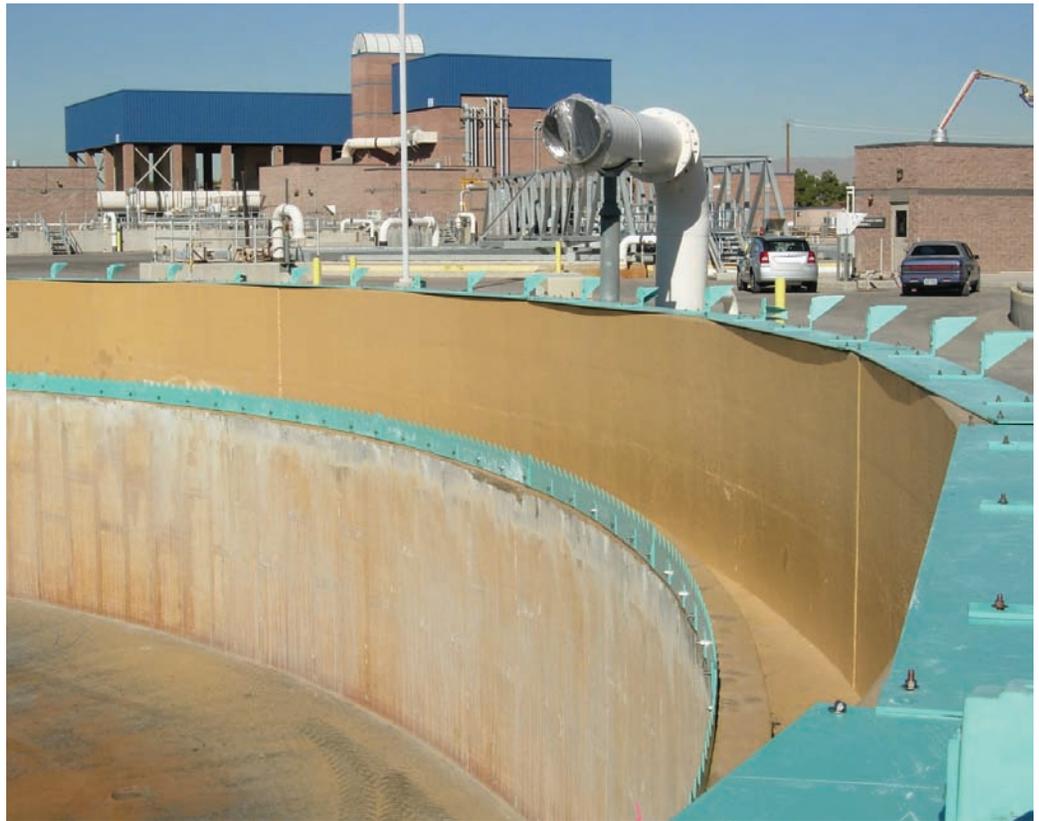
Applicators applied 125-mils of the SewerGard epoxy lining.

The installing contractor, Bryan Painting, successfully lined all 14 structures over a period of two years. The lining was applied to a thickness of 125-mils and, after curing, was tested to ensure there were no pinholes. In addition, the project underwent “High-Voltage Spark Testing” to identify

pinholes as well as adhesion testing to confirm that the lining was firmly adhered to the concrete substrate. This type of in-field quality control continues to gain in popularity as owners want more assurance that the chosen materials are installed correctly. Often times a third party inspector is employed to oversee the installation. **WW**
