Polymer Linings for Restoration & Corrosion Protection of Steel Surfaces: Crude Oil Storage Tank Repair and Reline in New Zealand

~ 2009 SSPC Corrosion Conference ~

*By: Greg Severyn, Sauereisen Inc., Greg Wiggins Pacific Concrete Protection and
Greg Bracey, New Zealand Refining Co.*

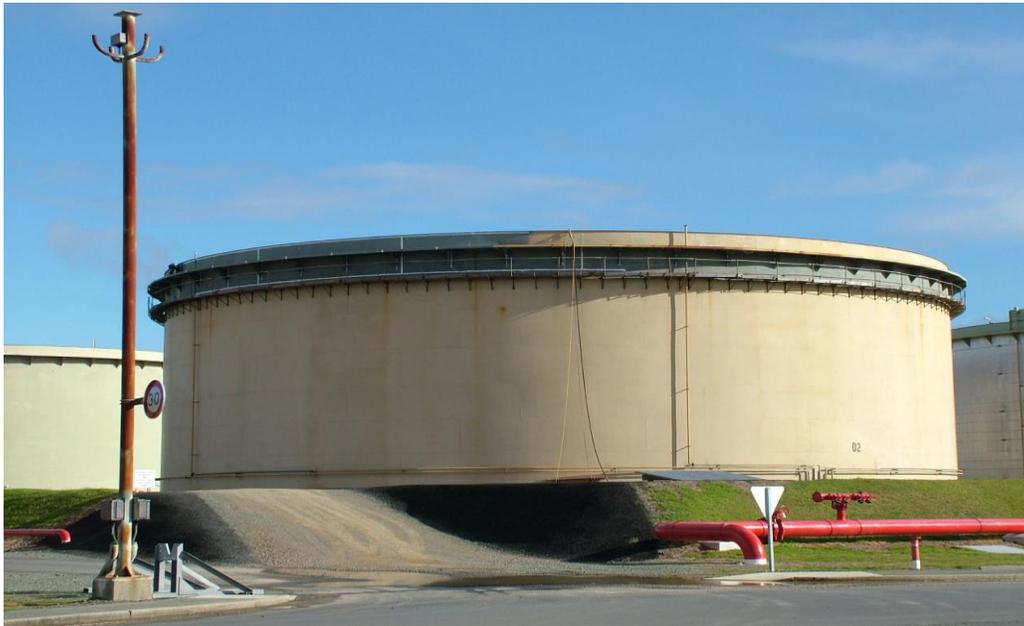
Figure 1

Exterior View of Crude Oil Storage Tank

When Marsden Point Oil Refinery in New Zealand needed to reline 3 steel crude oil storage tanks, Figure 1, the engineers began a search for a lining with the necessary properties to provide a long-term solution. Figure 2 is a schematic of a typical crude oil storage tank at the facility. The existing liners had failed in many areas, allowing severe corrosion of the carbon steel tanker, Figure 3. Magnetic Flux Leakage (MFL) scans of the steel showed a significant loss of steel thickness due to corrosion, in some areas greater than 25%. The internal linings that had been previously installed ranged in age from 12 to 15 years old and had failed over the entire floor area and 1 meter (~3.281 feet) up the sidewall. One of the 3 tanks was heated as it stored heavy crude.

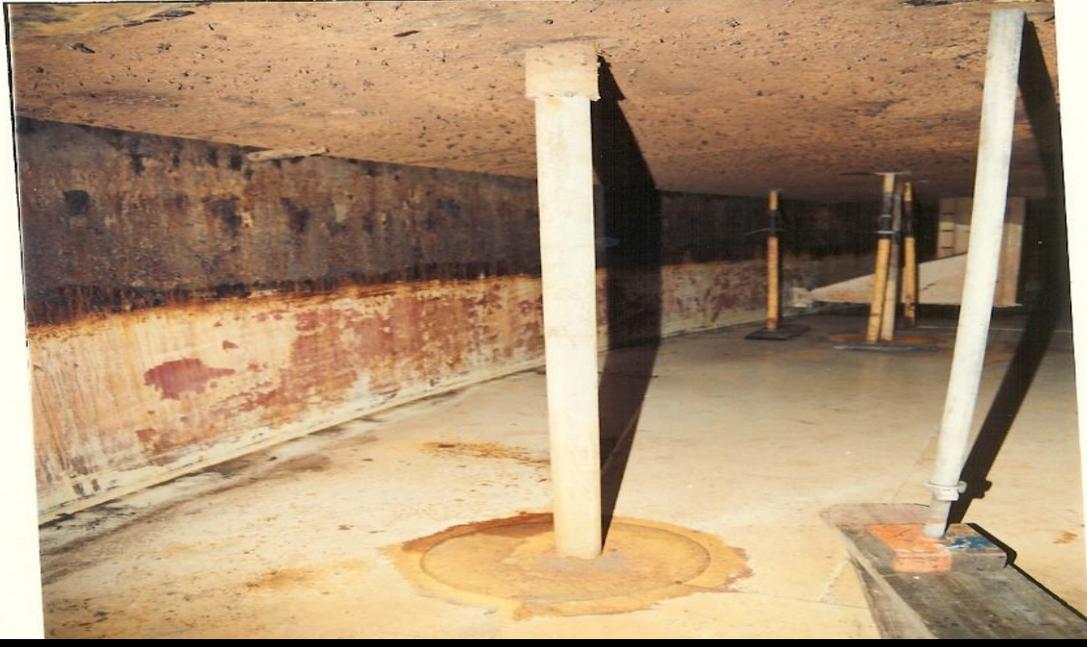
Figure 3
Corrosion of carbon steel

An analysis of the two failed coatings applied previously showed that a high permeance of the coatings and the presence of pinholes in the coating were the primary cause of the failures. The two linings were made by two different coatings manufacturers. Both were approximately 65% solids by volume bisphenol A epoxies which had been applied in 3 coats to a total film thickness of 15 to 16 mils (400 microns). The high solvent content is the primary reason for the high permeance and likely contributed to pinhole formations as well due to entrapped solvent in the cured coatings

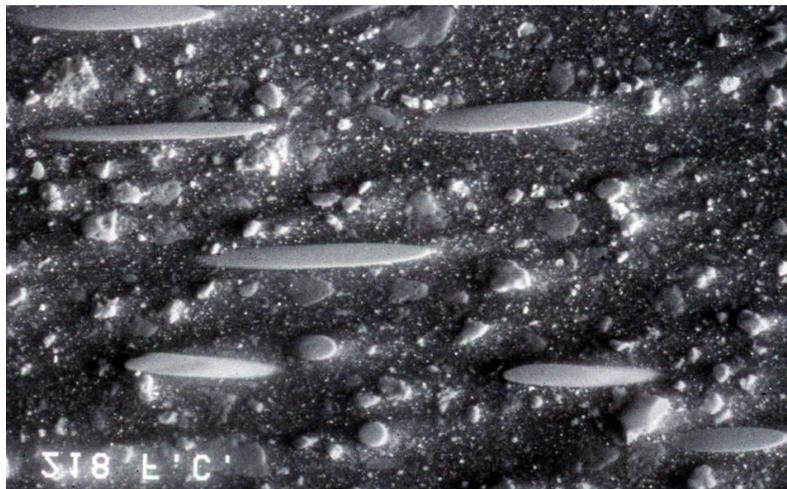
Figure 4
**Scanning Electron Microscope (SEM) of
Cross-section of interlocking fiber network**

To avoid these issues, an ultra-high solids coating, greater than 98% weight solids, with a very low permeance was investigated. This particular coating is a fiber-reinforced epoxy with a blend of discrete fibers. The fibers not only aid in physical reinforcement, especially in the critical flexural properties and crack resistance, but also greatly reduce permeance. Independent lab tests show a permeance reduction of more than 100-fold when the coating incorporates these particular fiber blends. To further ensure maximum chemical-resistance and minimum permeance, New Zealand Refining Company (NZRC) chose a novolak epoxy. Novolak epoxies have inherently better physical properties, lower permeance and generally better chemical resistance than other types of epoxies. Figure 4 is a Scanning Electron Microscope (SEM) of a cross-section of this lining material. Note how the fiber strands overlap and stack. The average number of layers of fiber per mil of coating exceeds 100 layers. This results in a highly tortuous path for any corrosive media, gas or liquid, to penetrate.

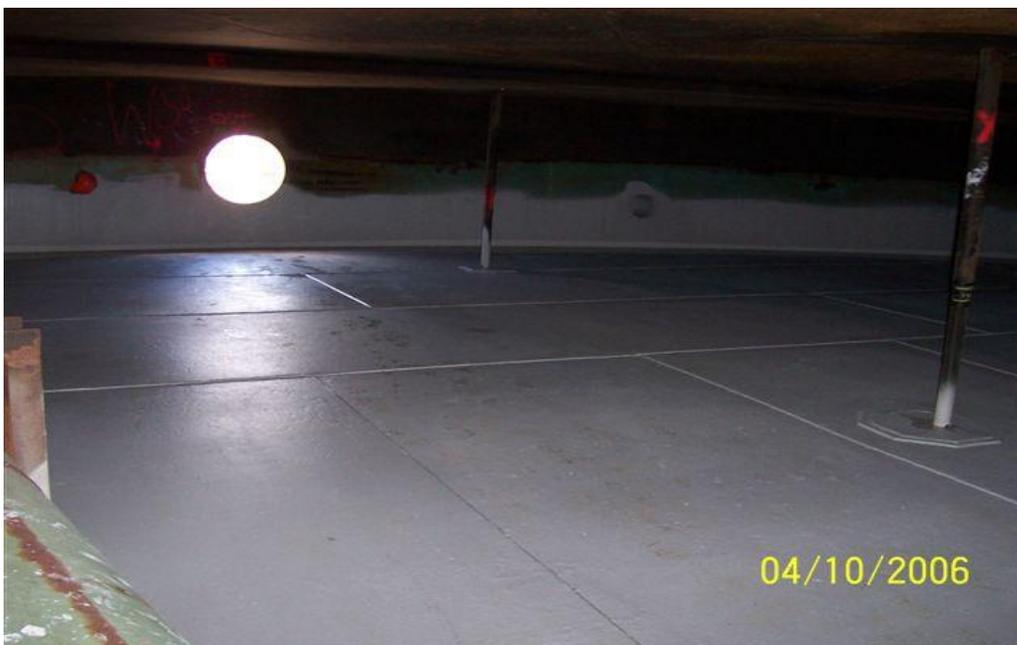
Figure 5
Completed Lining

The surface was cleaned by ultra-high pressure (UHP) water blast to remove oil, contaminates, and to prepare the area for inspection and steel repair. The surface was blasted using garnet to SSPC-SP5 cleanliness and a steel grit sweep blast to a 2.5-4 mil (63.5-101.6 microns) angular profile prior to priming. After surface preparation the fiber-reinforced topcoat was applied in one coat, building to 40-50 mils (1016-1270 microns). This resulted in a permeability of 1.14 x (1 x 10⁻¹⁰) perm-inches (1.65 x (1 x 10⁻¹⁸) gm/ Pa-s-m), a very low value and one that will give excellent long-term penetration protection. Following a cure of 2 days the tanks were placed back in service. This lining is expected to provide 12 to 15 years of service, see Figure 5 (completed lining).
