# Polymer Concrete for Structural Restoration and Corrosion Protection of Concrete Support Columns

David E. Snider and Heather M. Ramsey of Sauereisen Inc.

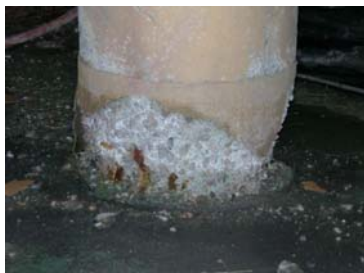
The leakage, primarily copper sulfate and 25% sulfuric acid at a pH of 1.0 or less, corroded not only the concrete but more significantly the No. 8 reinforcement bar (rebar) encased in the concrete. Corrosion of the rebar resulted in an increase of internal pressure due to expansion of the corrosion products, therefore putting the concrete in high tensile stress. The direct effect of this stress was cracking and spalling of the concrete. Figure 1 shows a typical degraded column requiring restoration.

**Figure 1. Column Degradation.**

The original construction of the columns used No. 8 rebar spaced 6-inches on center vertically and 18-inches on center horizontally. The refinery’s standard repair procedure was to remove corrosion products from the concrete and steel and then to top them with a polymer-modified portland-cement mortar. This standard repair method requires two (2) to three (3) days per column, and although temporarily affective, did not meet the company’s desire for a long-term solution. They decided upon a new approach using a polymer concrete (PC), which is a bisphenol A based-epoxy. This material is

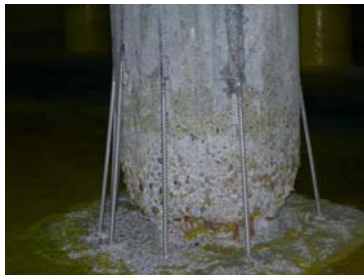
designed for maximum flowability, mechanical properties and chemical resistance. The PC repair system utilizes the polymer concrete for encapsulation, chemical protection, mechanical support and resistance to physical abuse. Figures 2 illustrates the method by which the stainless steel rebar was attached to the columns after surface-preparation. Stainless steel rebar was imbedded into the concrete floor using an epoxy mortar. Channels were saw-cut vertically in the concrete column. These channels provided a recess into which the rebar was bent and then secured into place with the epoxy mortar. Grouting of the rebar with this high strength epoxy mortar also served to provide tensile stress relief. By lowering stress relief, corrosion rates are reduced.

**Figure 2. Stainless steel rebar bent and grouted into the channels.**

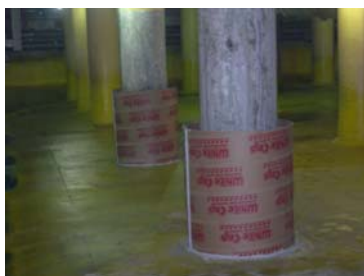
To further ensure structural integrity and to upgrade seismic capabilities, the company chose to use fiberglass reinforcement (FRP) strips and wraps under the PC. The strips were installed vertically on the columns and a fiberglass fabric was wrapped around the columns horizontally. The columns were formed and the polymer concrete was poured into place completely encapsulating the columns, the rebar and the FRP. This method required two (2) days per column. To date, 75 columns have been repaired using this method. Figures 3 and 4 show the forming and pouring of the PC. Figure 5 shows the PC after the form has been removed and the FRP that was applied to the columns.

**Figure 3. The forms placed around the column.**

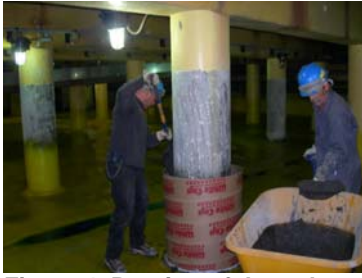
**Figure 4. Pouring of the polymer concrete.**

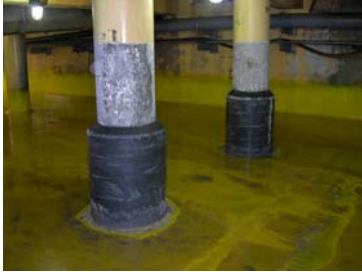
**Figure 5. Columns after removal of forms.**

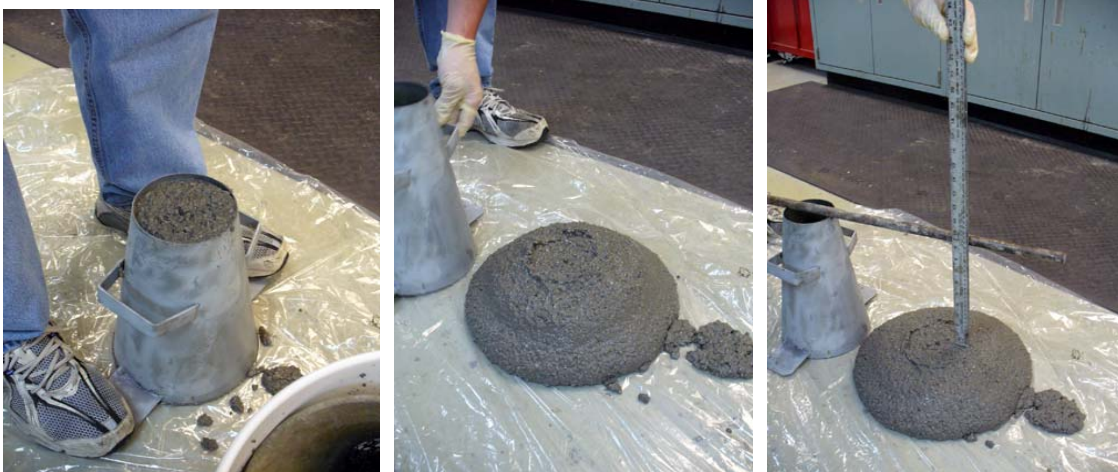
As mentioned earlier, an important property of the PC is the flowability. The test for this property is ASTM C-143 and measures the “slump” of the polymer concrete. Slump is defined as the amount that the molded cone of fresh paste sags, or slumps, from the original height of a standard 0.5 cubic foot molded cone (Figure 6). A slump of 6 inches is considered to be flowable. This particular polymer concrete exhibits a slump of 8-inches, which is very flowable. Figures 7 and 8 illustrate the flowability of the polymer concrete mixture. Table 1 lists some of the other physical properties of the polymer concrete used on this repair that were important considerations.

**Figures 6-8: Filling the slump cone, cone removal, measurement of polymer concrete slump.**

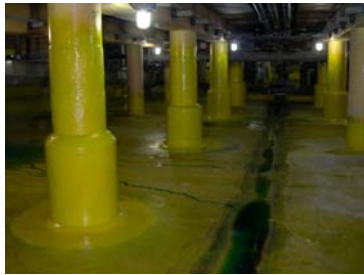
Coatings will typically have a service life of 8 to 15 years depending upon the exposure and physical abuse. However, in this case, typical service life of coatings was six months. Their service life is also affected and somewhat limited as a result of application thickness. Coatings are generally applied at thicknesses ranging from a few mils up to a few hundred mils. Polymer concretes, however, are applied at a minimum thickness of 1 inch and may be applied as thick as 18 inches. The thickness of barrier coatings determines the overall permeability, which is a measure of water vapor's ability to pass through a material. If the coating is less than 250 mils, the method used to determine permeability is based on the water-vapor transmission (WVT) test ASTM E-96 or ASTM D-1653. Permeance is calculated from WVT. Permeability is obtained by multiplying permeance by thickness. A permeability of  $10^{-8}$  ( $1.49 \times 10^{-17}$  grams/Pa•s•m) or less is generally considered to provide a good barrier coating. With PCs, hydraulic conductivity, measured per ASTM D-5084, is a more useful test. Hydraulic conductivity measures the volume of water that permeates or flows through the barrier coating. The Environmental Protection Agency (EPA) requires a value  $10^{-3} \text{ m}\cdot\text{s}^{-1}$  or less for secondary containment structures. The PC utilized on this restoration has a hydraulic conductivity of less than  $10^{-15} \text{ m}\cdot\text{s}^{-1}$ , which is about the practical lower limit for the test method. Also due to the thickness, and other considerations, the service life of a polymer concrete is longer and requires far less maintenance. Experience with PCs by this manufacturer has shown no failures after 15 years of service. Laboratory evaluations coupled with field observations indicate the service life of PCs to be typically greater than 25 years. Figure 9 illustrates the completed

column, including a protective topcoat for the FRP reinforced concrete. Although not needed for functionality, the topcoat was extended over the PC for aesthetics and coating integrity.

**Figure 9. Completed column repair.**
