# CANADIAN PULP MILL CLARIFIER

## Rehabilitation & Protection From Chemical Attack

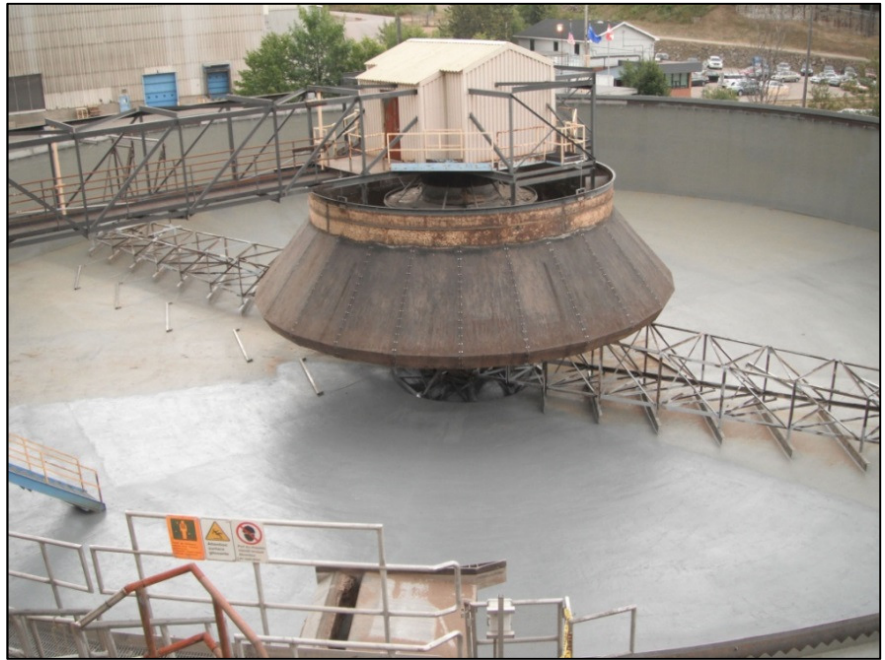
When Resolute Forest Products was determining a solution for rehabilitation and protection of their 50,000 square foot concrete clarifier damaged from mild chemical attack and abrasion from their pulping process they contacted MBI Corexcel, a local corrosion-resistant specialized contractor, for assistance. General Manager - Pierre Fauteux - called Solhydroc, a long tenured distributor of Sauereisen, Inc (USA) products for assistance. Owner Pierre Auger met with Resolute Forest Products personnel months in advance of construction to ensure that the customer would be satisfied with the recommended engineered solution offered. Mr Auger commented "When Mr Neron of Resolute and Pierre Fauteux asked me to provide them with a solution to their clarifier I immediately thought of the Sauereisen products. "In my years of association with Sauereisen I knew they could meet the challenges and offer long term service. Their technical service is unmatched in the industry and I felt very comfortable that the customer would be satisfied. Plus, Quebec (Clermont) is a beautiful place to visit in the early summer."

Resolute Forest Products, Inc (Clermont, Quebec, Canada) manufactures 345,000 metric tons of quality newsprint paper exported to the United States and Europe each year. The solution required coordination of the facility, contractor, and coatings manufacturer so that project completion would not disrupt operation and result in minimum downtime during construction. The materials selected were: a vertical trowel-applied epoxy repair product; a pour & spread horizontal repair material and 40 mils of Sauereisen NovolaK fiber-reinforced, spray-applied lining.

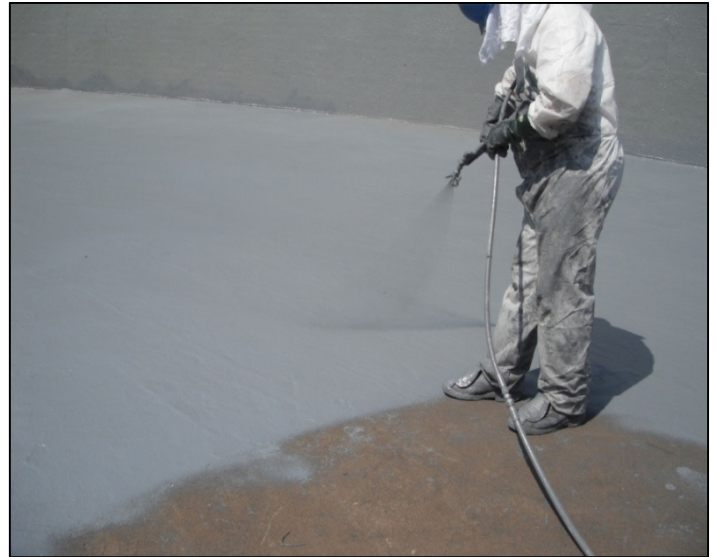
Upon arriving at the job site, it was recommended that the contractor do surface preparation on 100 square foot area(s) of both the wall and floor; apply applicable epoxy mortar repair system; and spray the fiber reinforced system under the supervision of Mr Pete Jansen – Sauereisen Technical Service Manager. This activity would permit the contractor's employees to familiarize themselves with the materials and any idiosyncrasies particular to spraying fiber-filled material through a 50:1 airless pump. Also, it would enable Sauereisen to approve acceptable surface preparation methods and make recommendations for any improvements they thought would assist in making the project more successful. Furthermore, once the 10 by 10 area(s) were completed, all parties (Sauereisen, Solhydroc, Resolute, & MBI Corexcel) could agree upon how the final product would appear throughout the entire 50,000 square feet of surface.

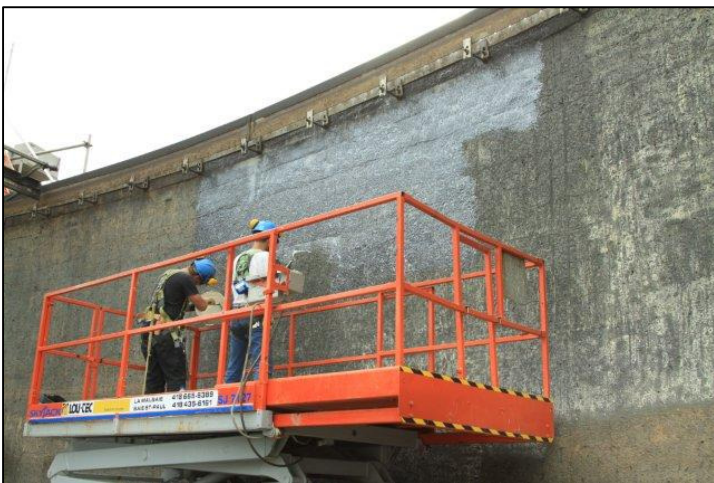
After the vertical wall area was permitted to dry overnight, the area was repaired with epoxy mortar by hand trowelling the with a rubber squeegee.

The epoxy repair mortar is specifically formulated to bond to rough concrete surfaces with the ability to fill imperfections and bug holes without sagging or outgassing. Not only does the concrete surface get refinished to an acceptable surface for application of the lining; but, the epoxy concrete repair material does not require a primer and offers a 72- hour recoat time for coordination of your lining or coating application.

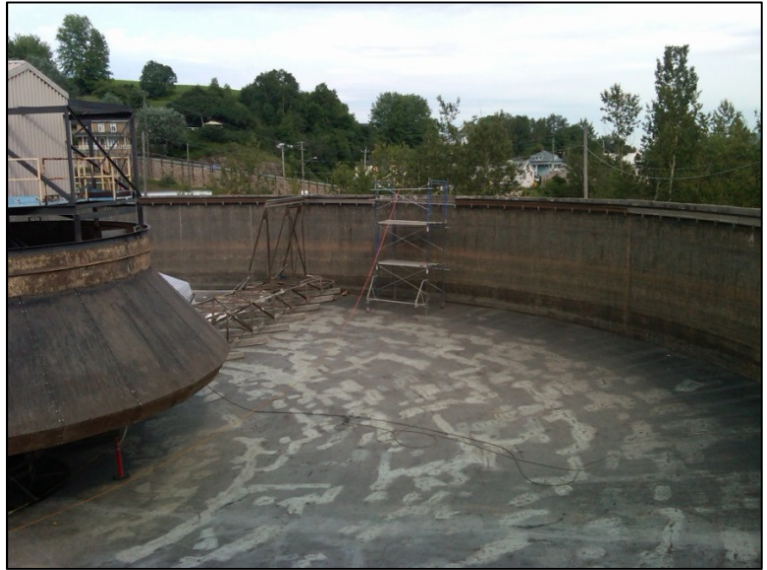
The epoxy pour & spread material was squeegeed to the prepared surfaces and then an additional broadcast of sand to excess was applied into the pour & spread repair material.

After the epoxy pour & spread sand mixture was allowed to cure overnight, the excess sand was swept from the surface and collected for use on adjacent area on the other side of the rake arms.

The pour & spread broadcast repair system provided a more durable basecoat and the sandpaper-like surface profile recommended by the manufacturer to ensure adhesion and minimal outgassing of the epoxy lining system that would be sprayed upon it.
