CANADIAN PULP MILL CLARIFIER

Rehabilitation & Protection From Chemical Attack

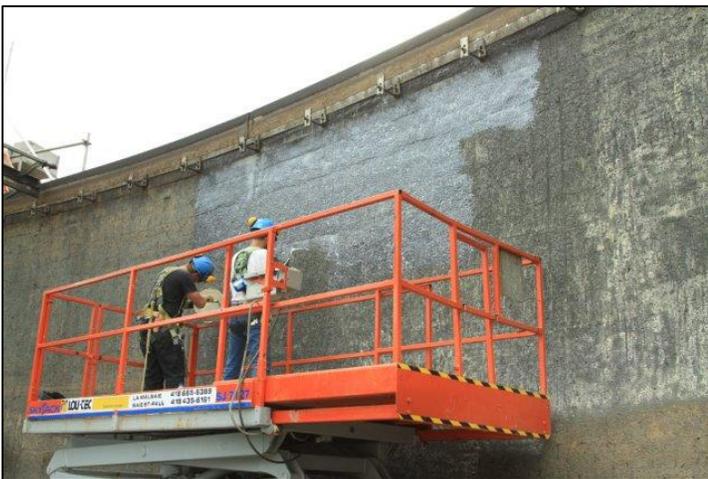
After the vertical wall area was permitted to dry overnight, the area was repaired with epoxy mortar by hand trowelling the with a rubber squeegee.

The epoxy repair mortar is specifically formulated to bond to rough concrete surfaces with the ability to fill imperfections and bug holes without sagging or outgassing. Not only does the concrete surface get refinished to an acceptable surface for application of the lining; but, the epoxy concrete repair material does not require a primer and offers a 72- hour recoat time for coordination of your lining or coating application.

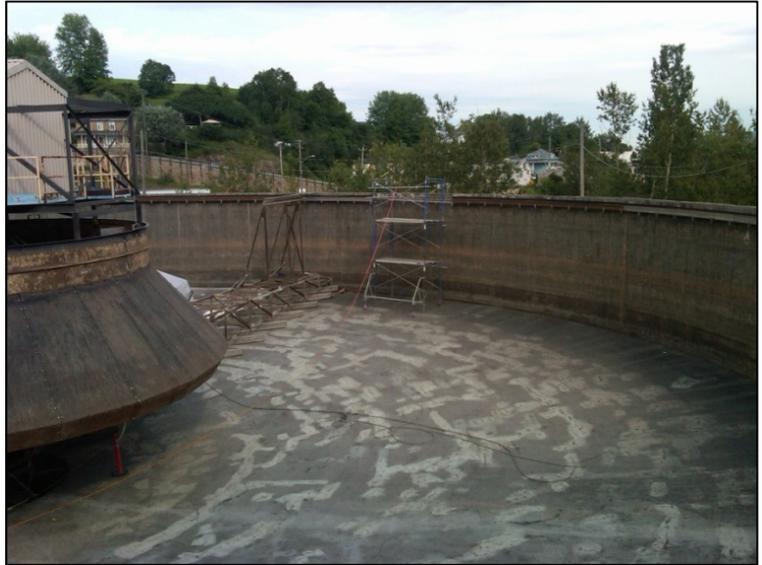
The epoxy pour & spread material was squeegeed to the prepared surfaces and then an additional broadcast of sand to excess was applied into the pour & spread repair material.

After the epoxy pour & spread sand mixture was allowed to cure overnight, the excess sand was swept from the surface and collected for use on adjacent area on the other side of the rake arms.

The pour & spread broadcast repair system provided a more durable basecoat and the sandpaper-like surface profile recommended by the manufacturer to ensure adhesion and minimal outgassing of the epoxy lining system that would be sprayed upon it.
