## Extreme Paper Mill Makeover

When Resolute Forest Products was determining a solution for rehabilitation and protection of their 50,000 square foot concrete clarifier damaged from mild chemical attack and abrasion from their pulping process they contacted MBI Corexcel, a local corrosion-resistant specialized contractor, for assistance. General Manager - Pierre Fauteux - called Solhydroc, a long tenured distributor of Sauereisen, Inc (USA) products for assistance. Owner Pierre Auger met with Resolute Forest Products personnel months in advance of construction to ensure that the customer would be satisfied with the recommended engineered solution offered. Mr Auger commented "When Mr Neron of Resolute and Pierre Fauteux asked me to provide them with a solution to their clarifier I immediately thought of the Sauereisen products. "In my years of association with Sauereisen I knew they could meet the challenges and offer long term service. Their technical service is unmatched in the industry and I felt very comfortable that the customer would be satisfied. Plus, Quebec (Clermont) is a beautiful place to visit in the early summer."

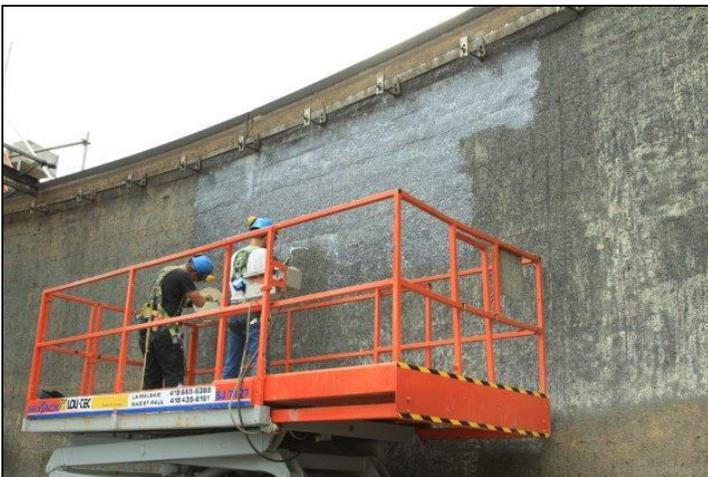
After the vertical wall area was permitted to dry overnight, the area was repaired with epoxy mortar by hand trowelling the with a rubber squeegee.

The epoxy repair mortar is specifically formulated to bond to rough concrete surfaces with the ability to fill imperfections and bug holes without sagging or outgassing. Not only does the concrete surface get refinished to an acceptable surface for application of the lining; but, the epoxy concrete repair material does not require a primer and offers a 72- hour recoat time for coordination of your lining or coating application.

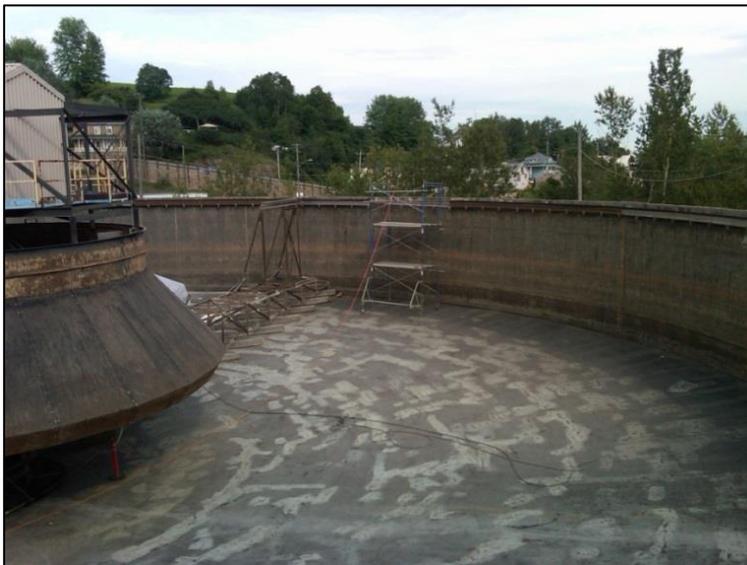
The epoxy pour & spread material was squeegeed to the prepared surfaces and then an additional broadcast of sand to excess was applied into the pour & spread repair material.

After the epoxy pour & spread sand mixture was allowed to cure overnight, the excess sand was swept from the surface and collected for use on adjacent area on the other side of the rake arms.

The pour & spread broadcast repair system provided a more durable basecoat and the sandpaper-like surface profile recommended by the manufacturer to ensure adhesion and minimal outgassing of the epoxy lining system that would be sprayed upon it.
